# REVIBRATION OF RETARDED CONCRETE FOR CONTINUOUS BRIDGE DECKS

UNIVERSITY OF ILLINOIS  
URBANA, ILLINOIS  
NOVEMBER 1969

FINAL REPORT  
NCHRP Project 18-1  
REVIBRATION OF RETARDED CONCRETE FOR CONTINUOUS BRIDGE DECKS

by  
H. K. Hilsdorf  
and J. L. Lott

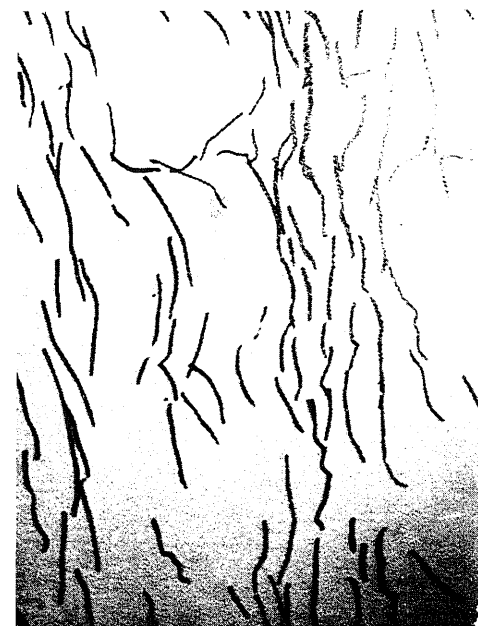
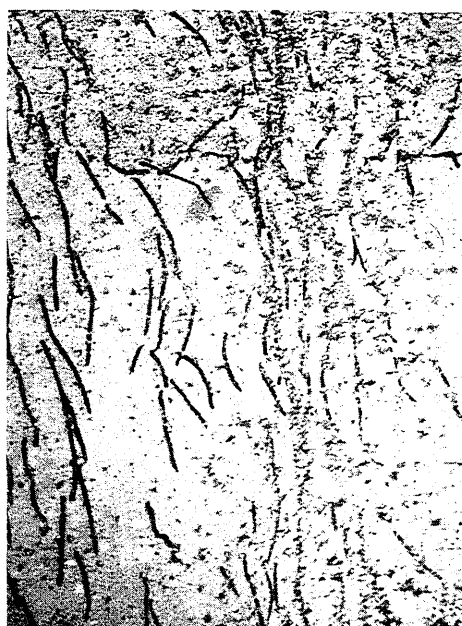
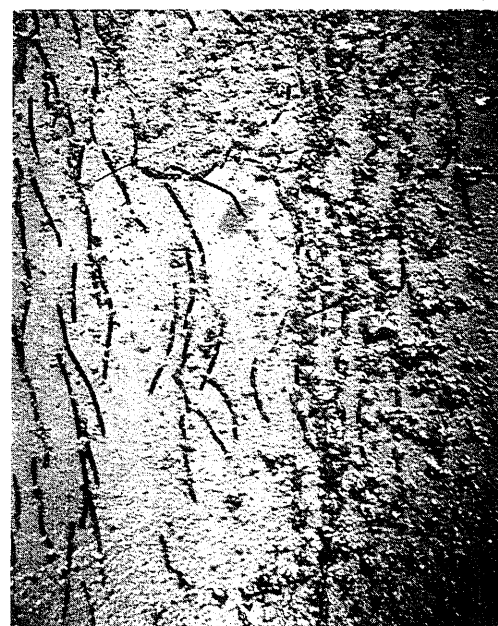
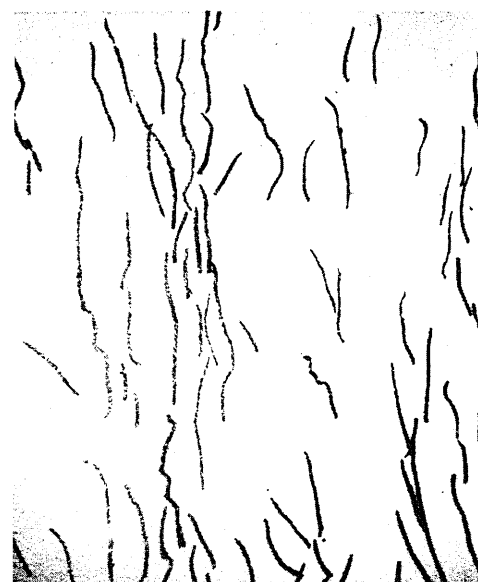
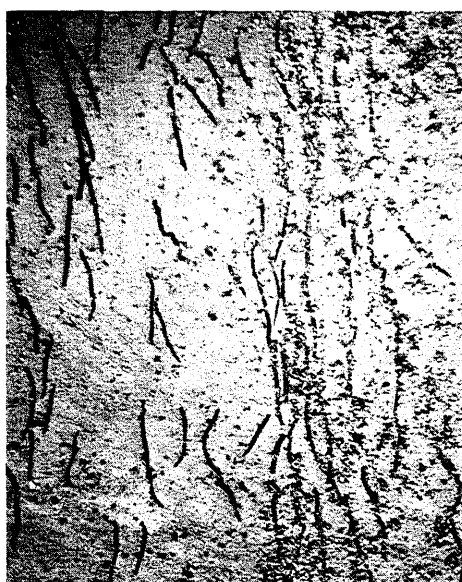
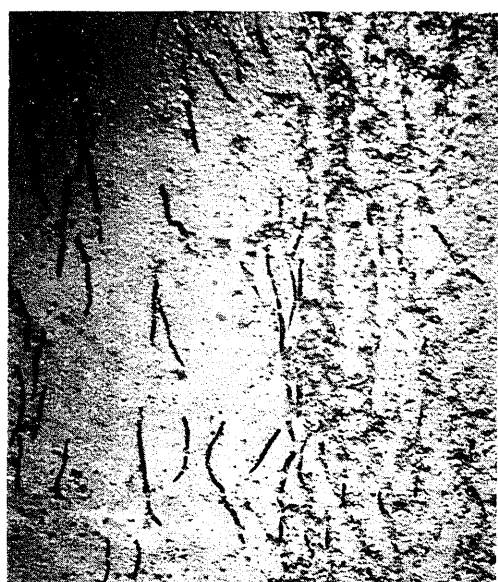
Cycles : 0  
Rating : 0

Cycles : 7  
Rating : 2-1/2

Cycles : 21  
Rating : 4

FIG. D4I a SURFACE DETERIORATION OF SPECIMEN SUD-SE-OA PHASE 3b  
SERIES 1D-NO REVIBRATION-SEVERE CRACKING

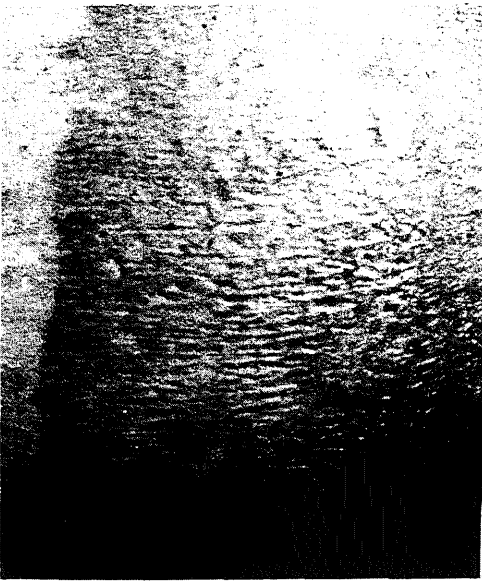
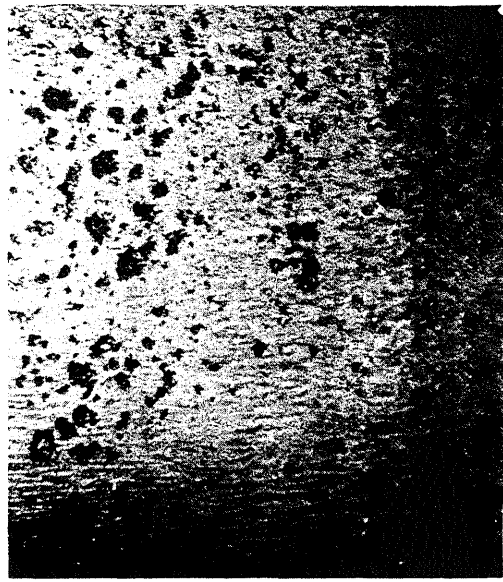
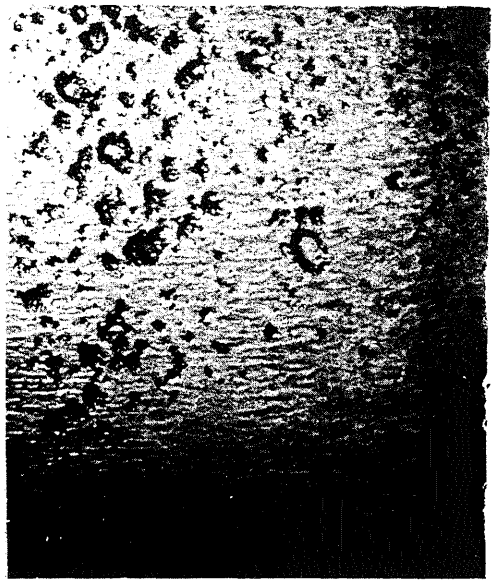
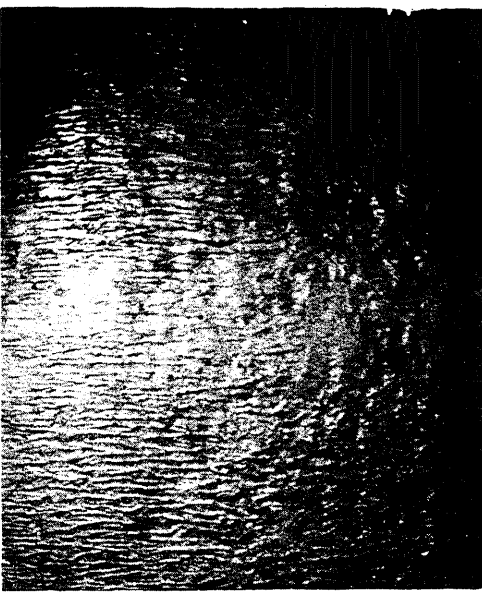
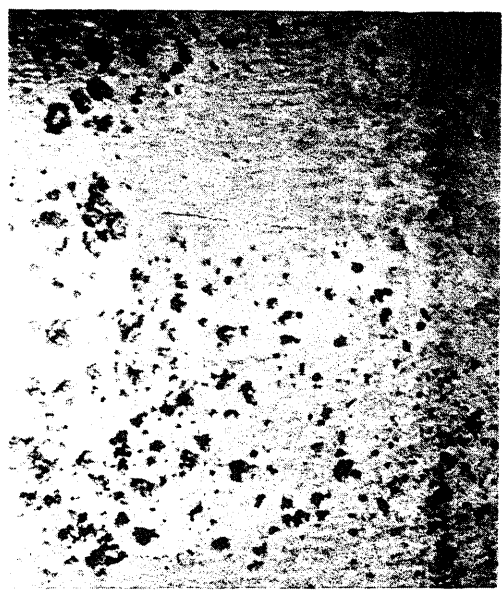
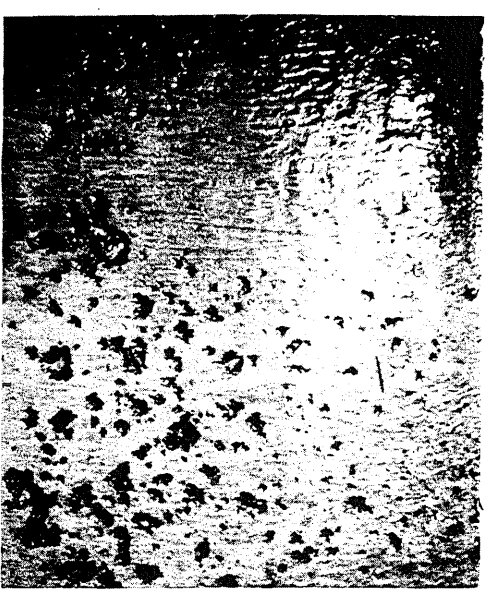
Cycles : 0  
Rating : 0

Cycles : 7  
Rating : 2

Cycles : 21  
Rating : 3

FIG. D 41 b SURFACE DETERIORATION OF SPECIMEN SUD-SE-80 PHASE 3b  
SERIES 1D - SURFACE REVIBRATION - ENERGY LEVEL 80 %

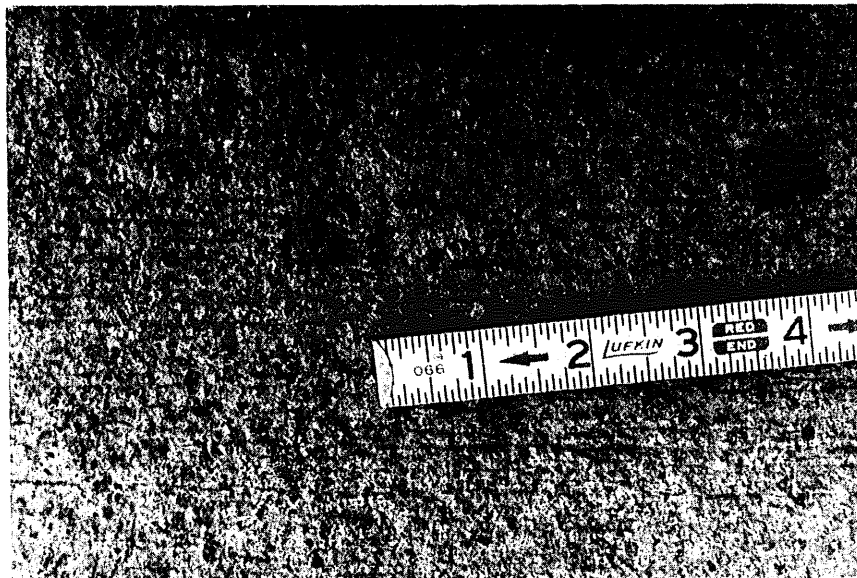
FIG. E54 CRACKS AFTER REVIBRATION OF SURFACE CRUSTED  
CONCRETE, BRIDGE DECK NO. 35 W - 40 - 5.00
